FINAL REPORT NUMBER 201U-MGA-04-06

SAFETY COMPLIANCE TESTING FOR FMVSS 201U
Occupant Protection In Interior Impact
Upper Interior Head Impact Protection

LAND ROVER IN THE UK
2004 LAND ROVER FREELANDER SE MPV
NHTSA No. C40602

MGA RESEARCH CORPORATION
446 Executive Drive
Troy, Michigan 48083

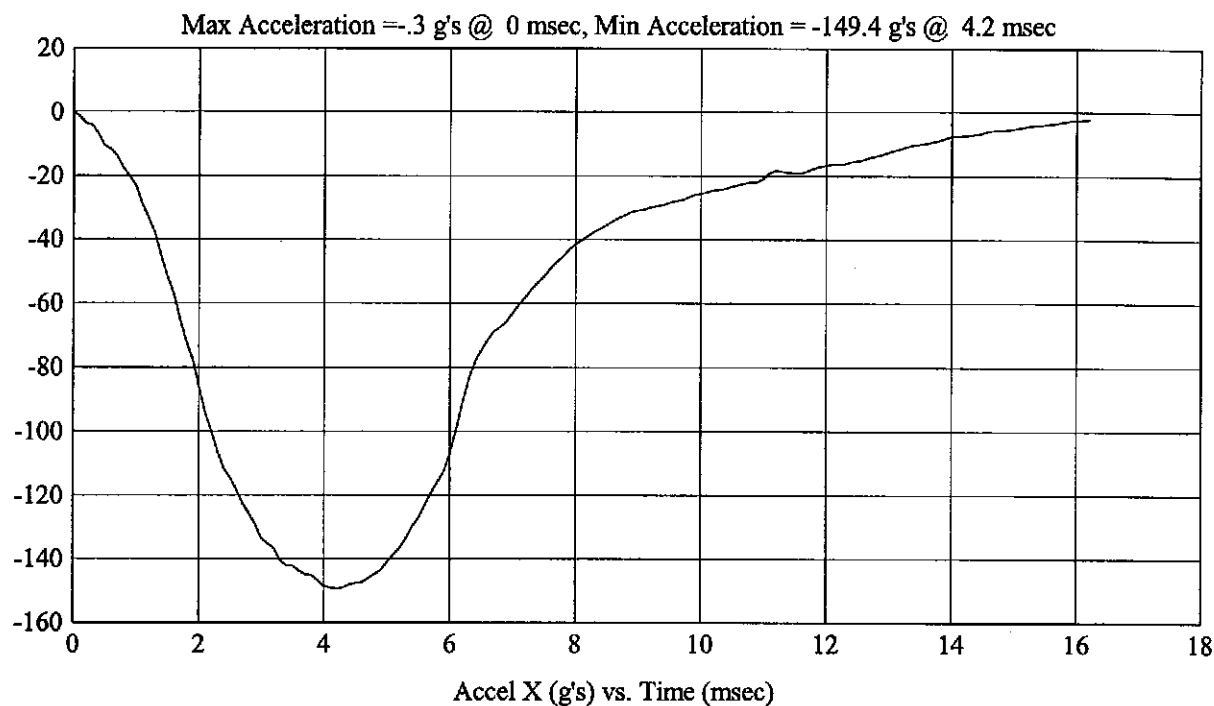
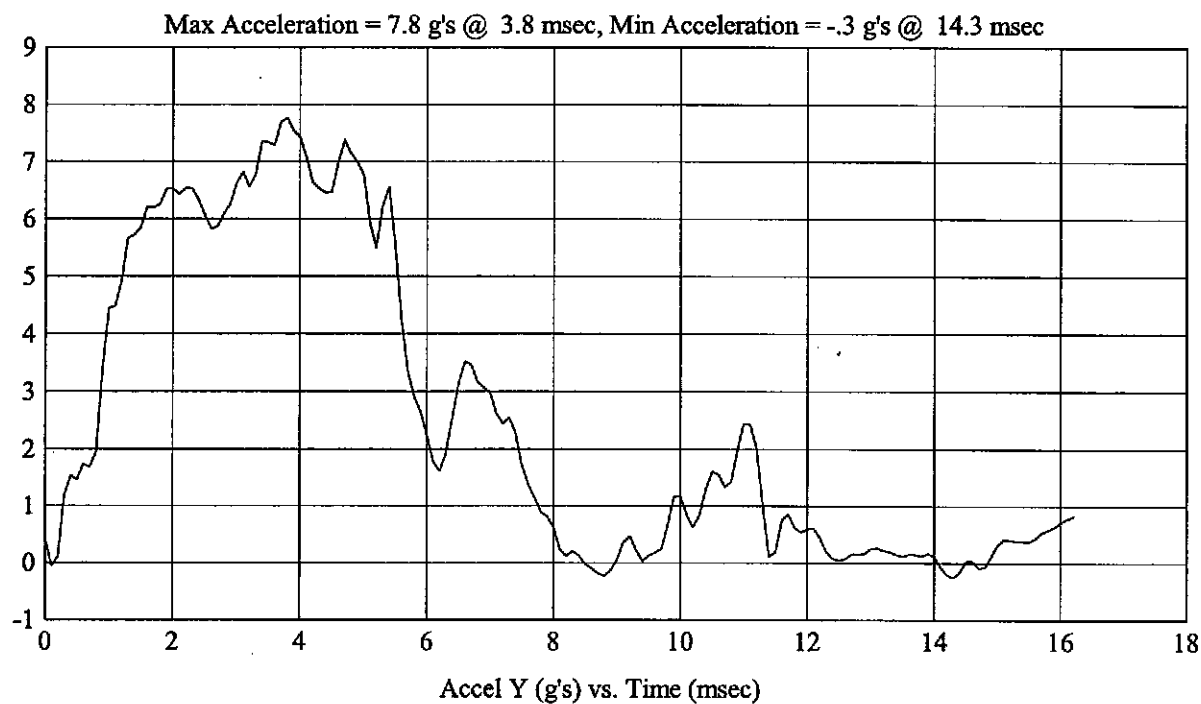
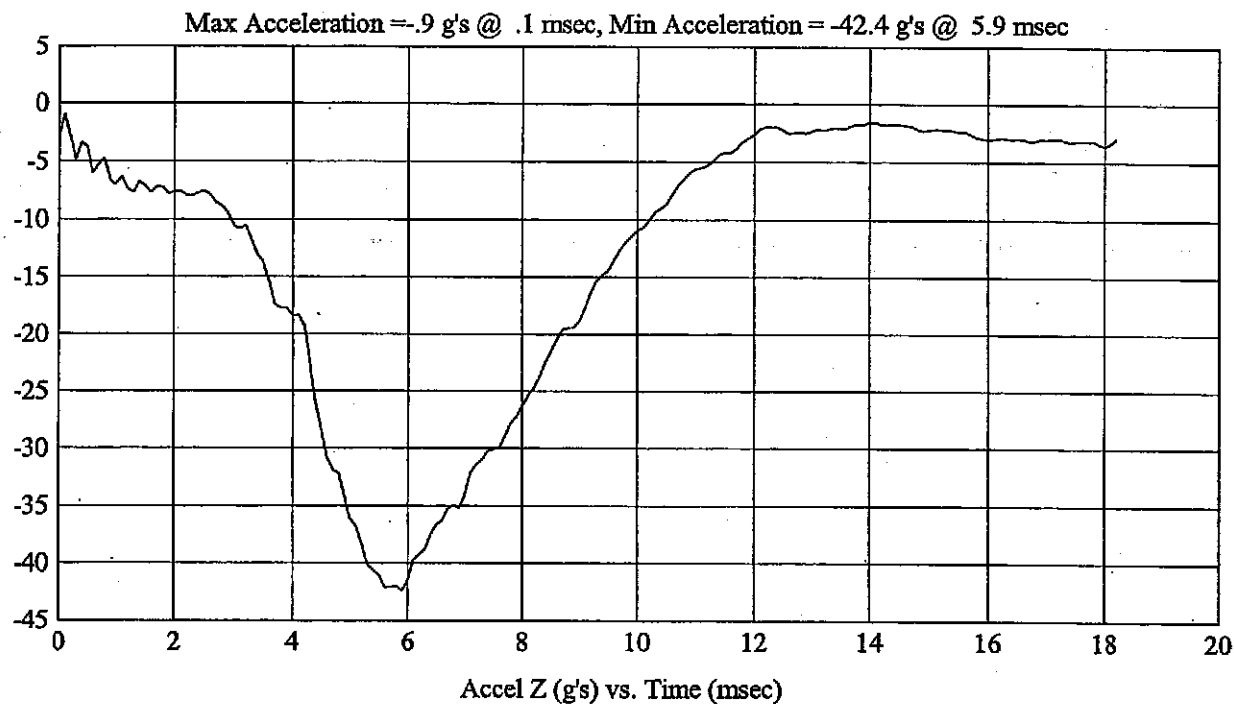
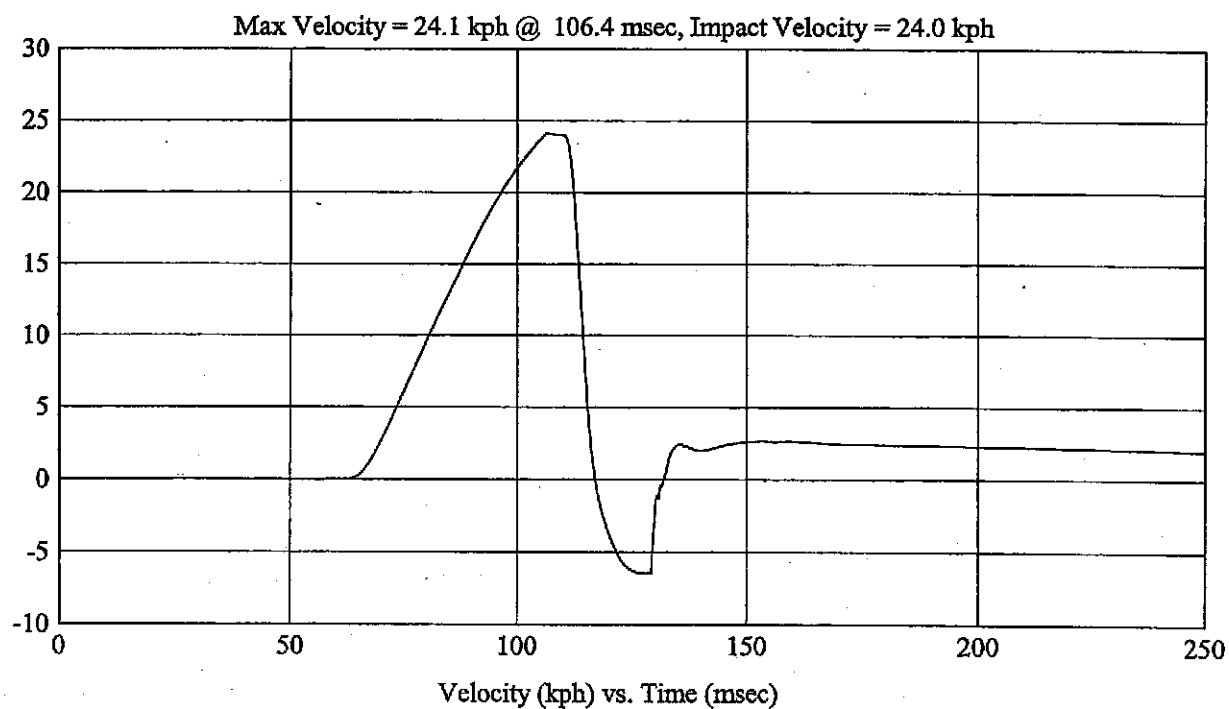
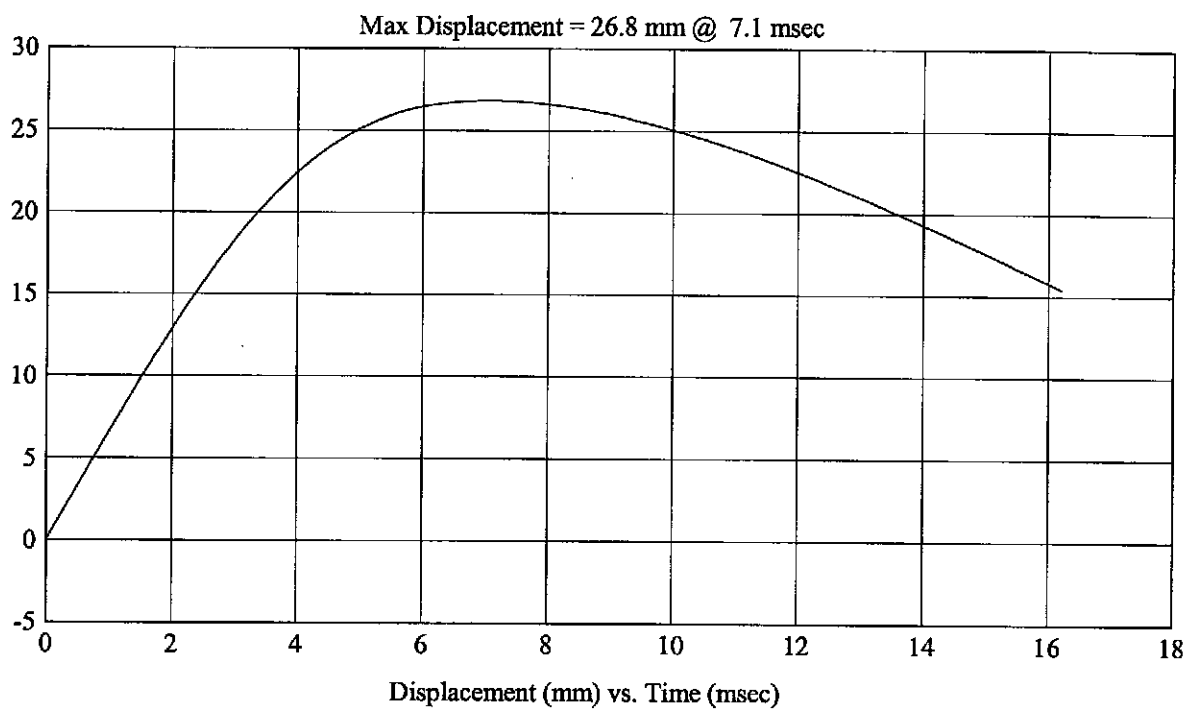
Model Year: 2004
Target: AP1
Vehicle Side: Right
Horz/Vert Angle: 109/30

HIC(d) = 831, HIC = 880, Delta T = 5.1 msec

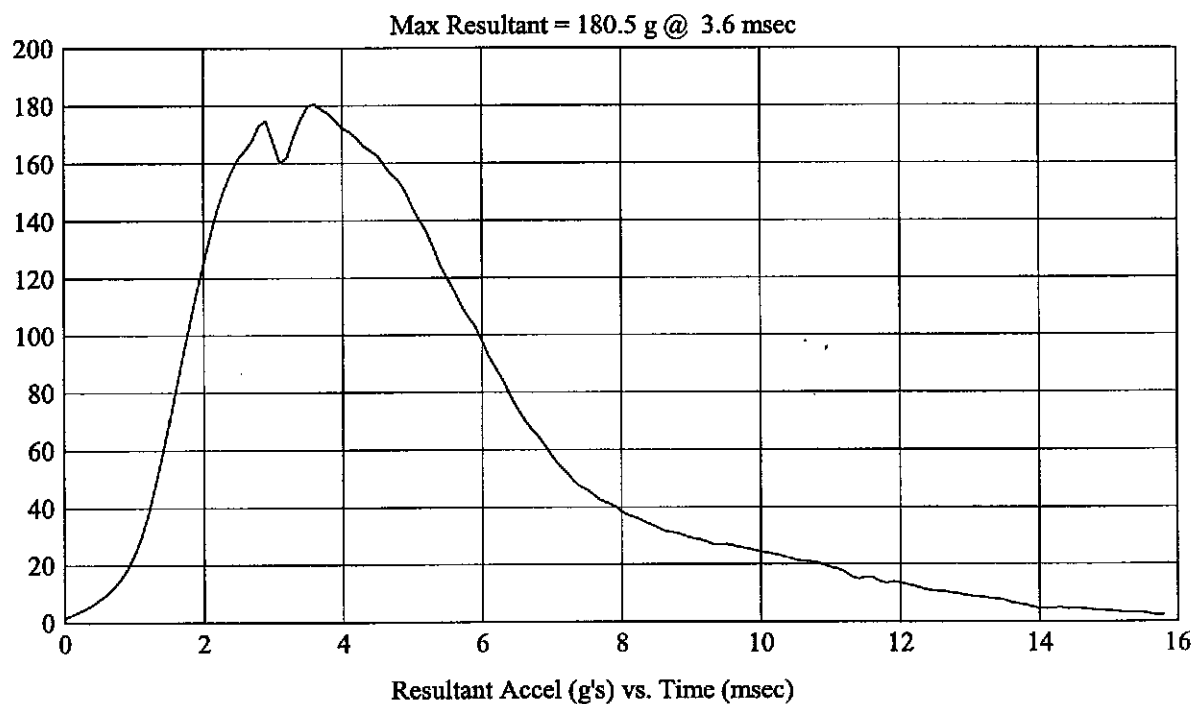
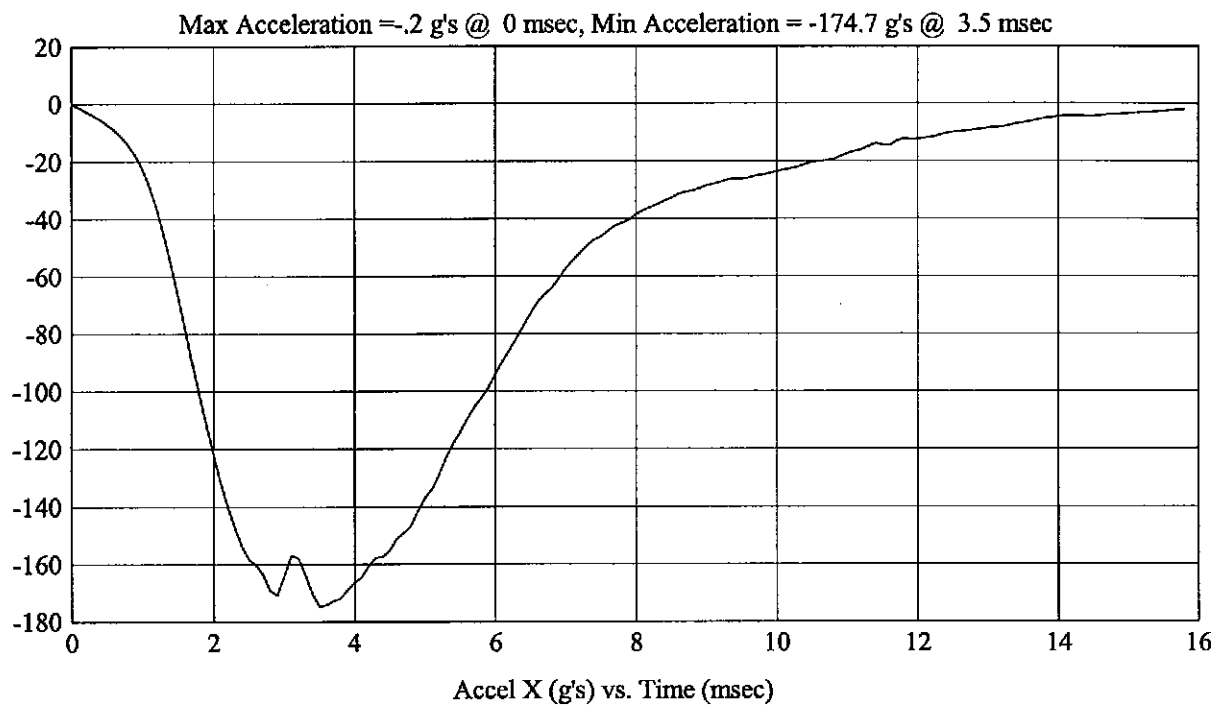
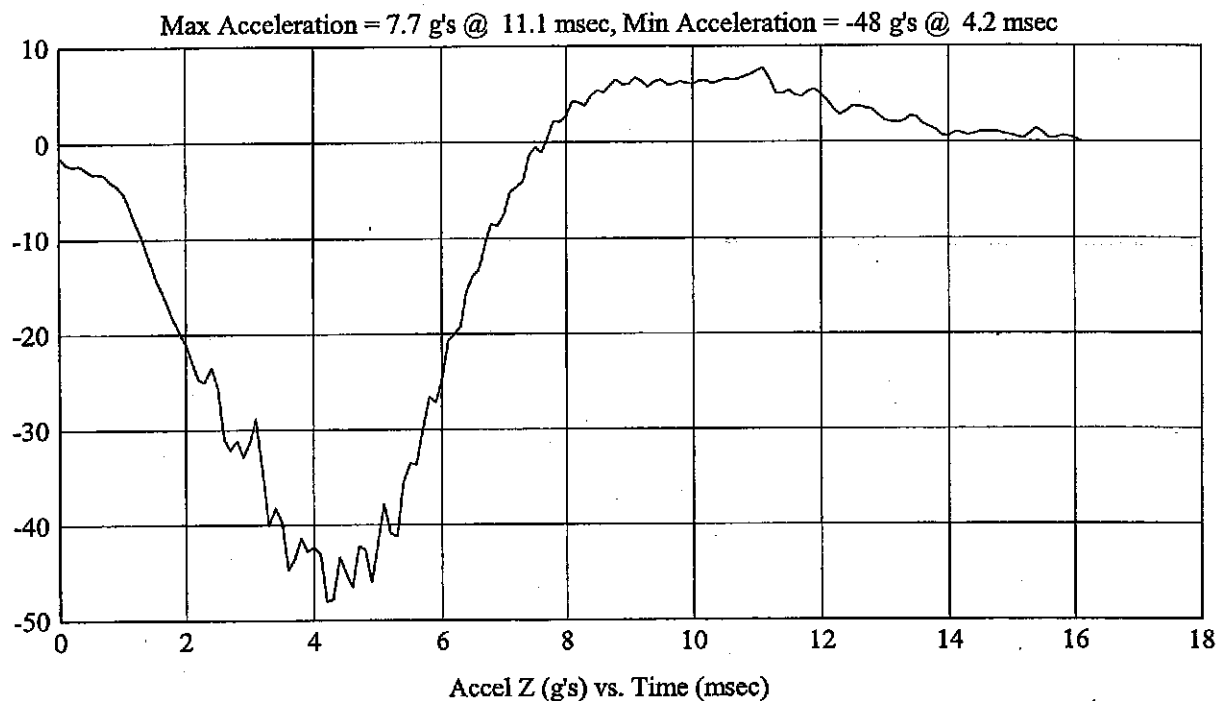
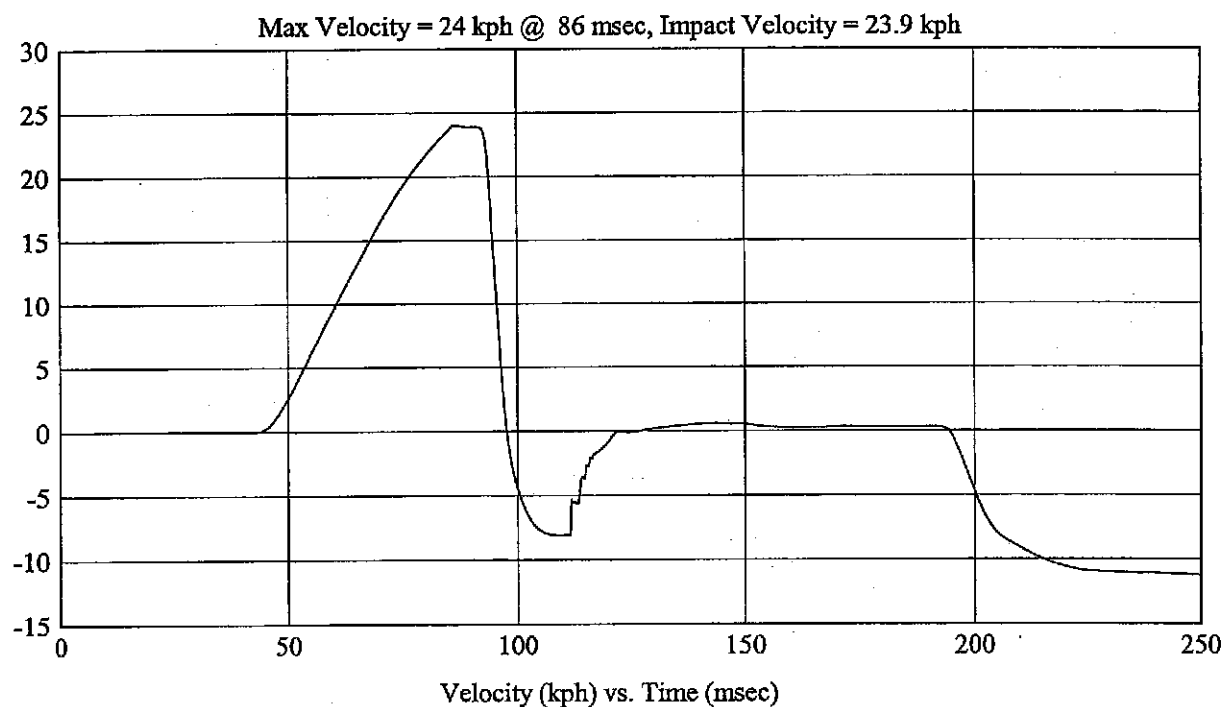
Model Year: 2004
Target: AP3
Vehicle Side: Right
Horz/Vert Angle: 152/31

AP3 Right: No visible damage. Apparent test failure.

HIC(d) = 1062, HIC = 1187, Delta T = 4.5 msec

APPARENT TEST FAILURE DESCRIPTION: A-PILLAR TARGET #3 (AP3), LOCATED ON THE LOWER PORTION OF THE A-PILLAR. THE HORIZONTAL AND VERTICAL ANGLES WERE 152 AND 31 DEGREES RESPECTIVELY. THE CALCULATED HEAD IMPACT CRITERIA(d) WAS 1062, AT AN IMPACT VELOCITY OF 23.9 KPH.

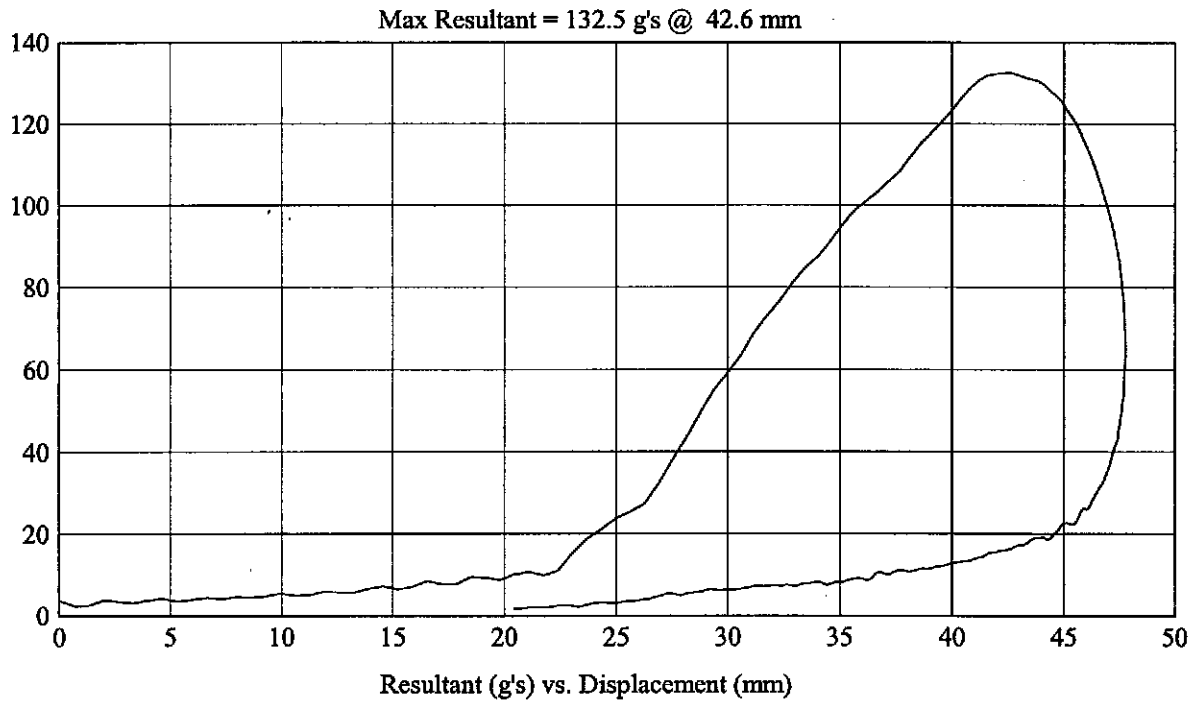
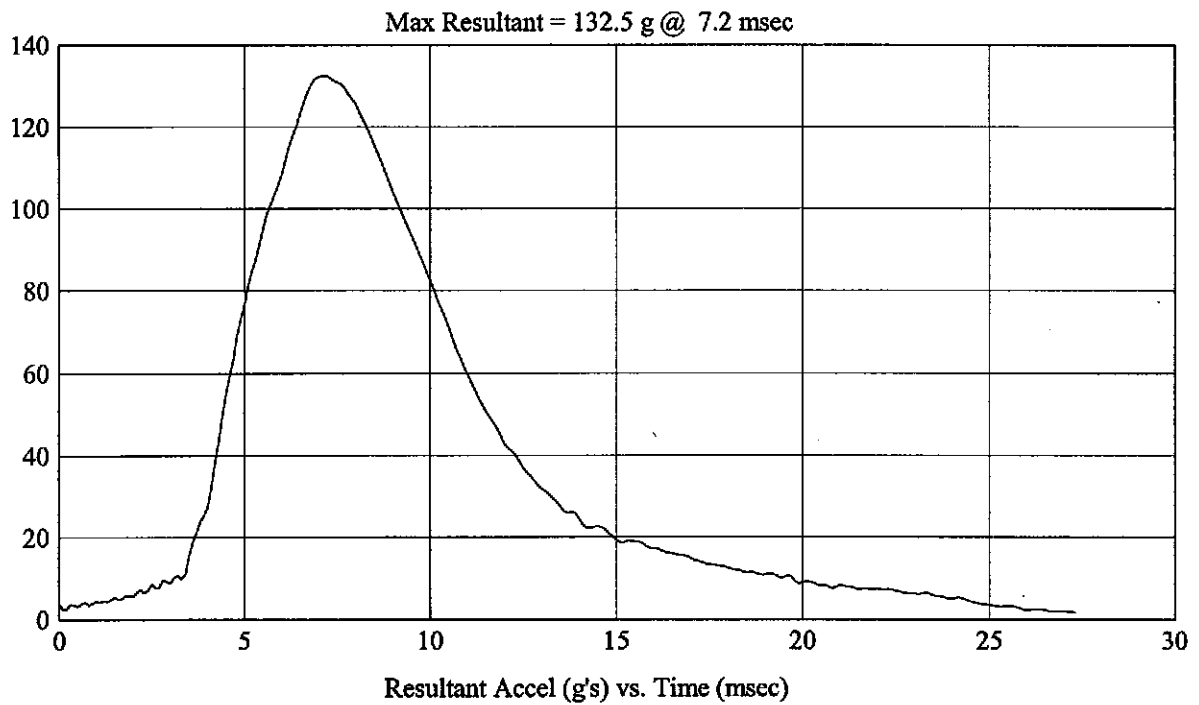
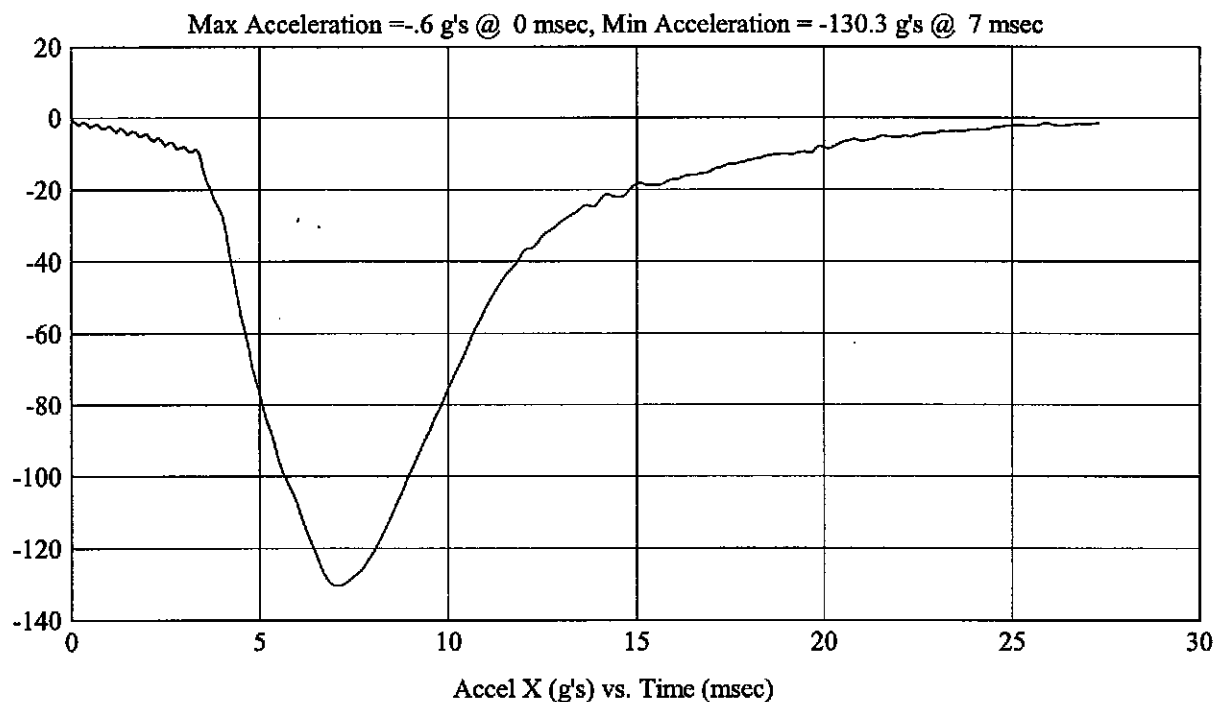
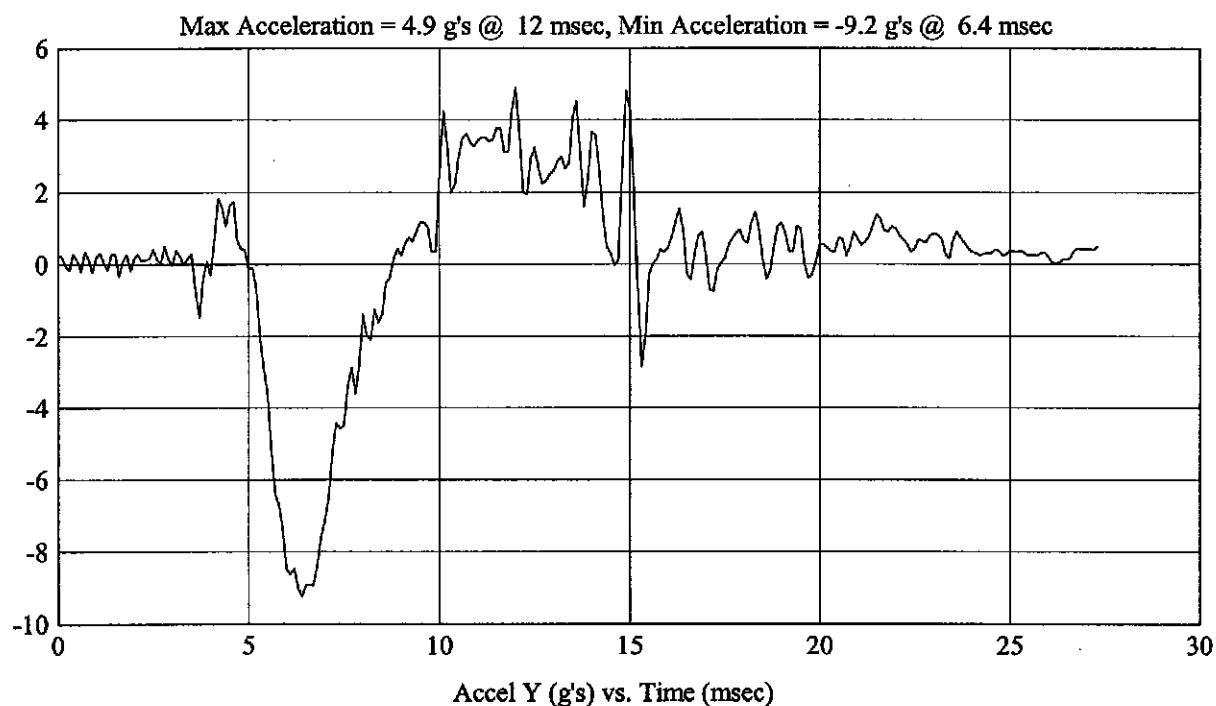
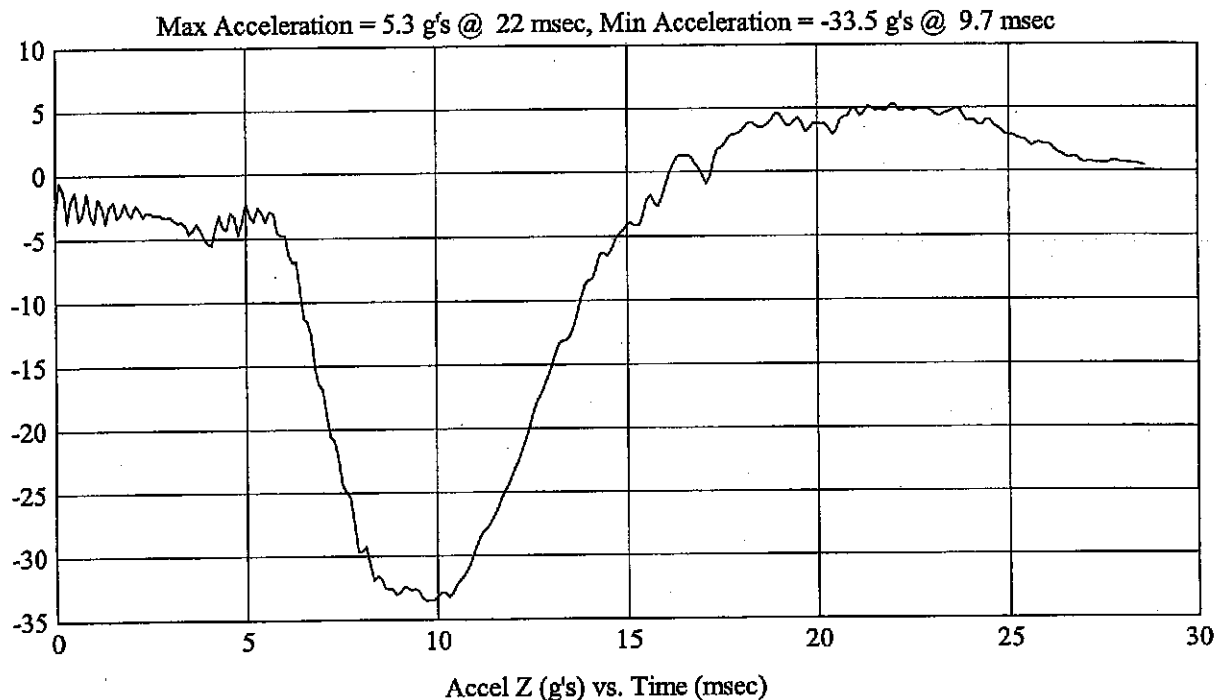
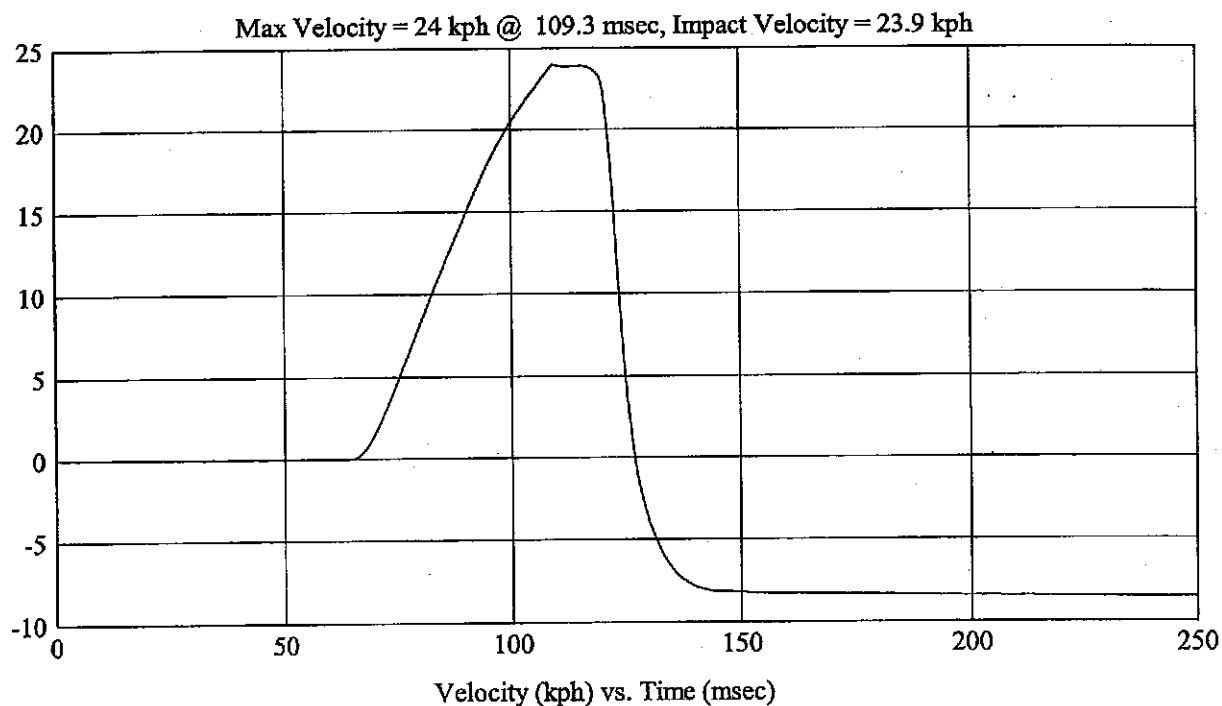
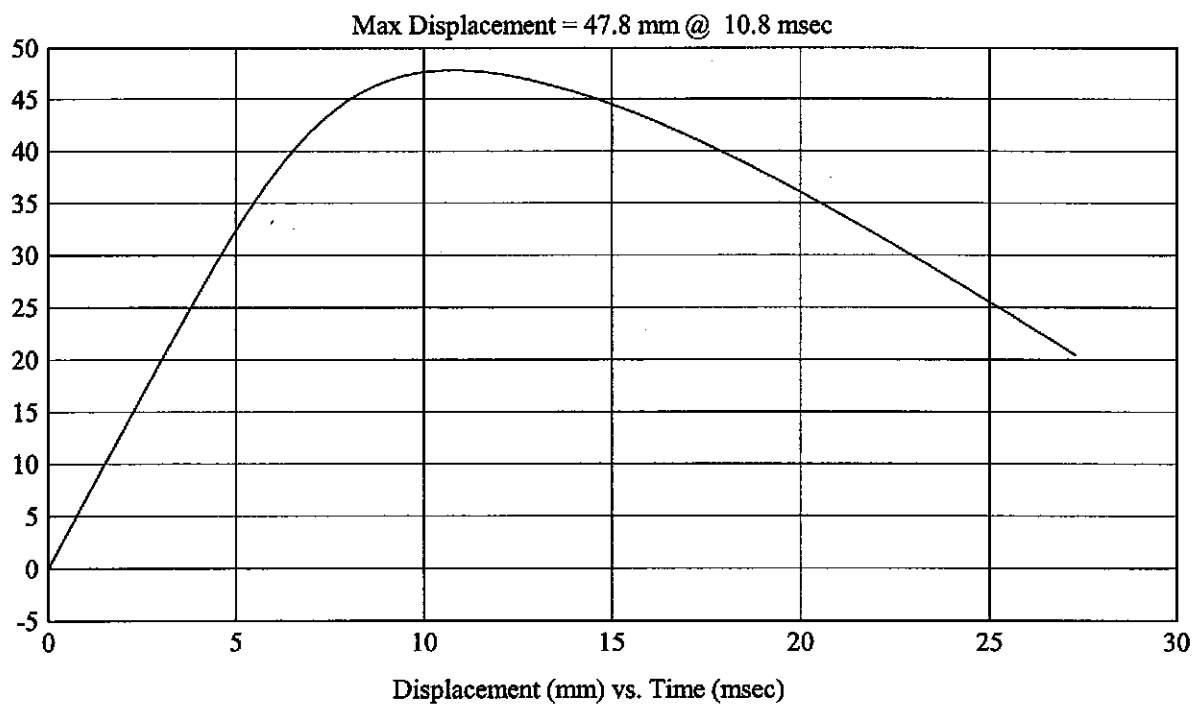
Model Year: 2004
Target: BP1
Vehicle Side: Left
Horz/Vert Angle: 270/10

BP1 Left: B-Pillar trim was compressed into the side rail.

HIC(d) = 676, HIC = 675, Delta T = 6.2 msec

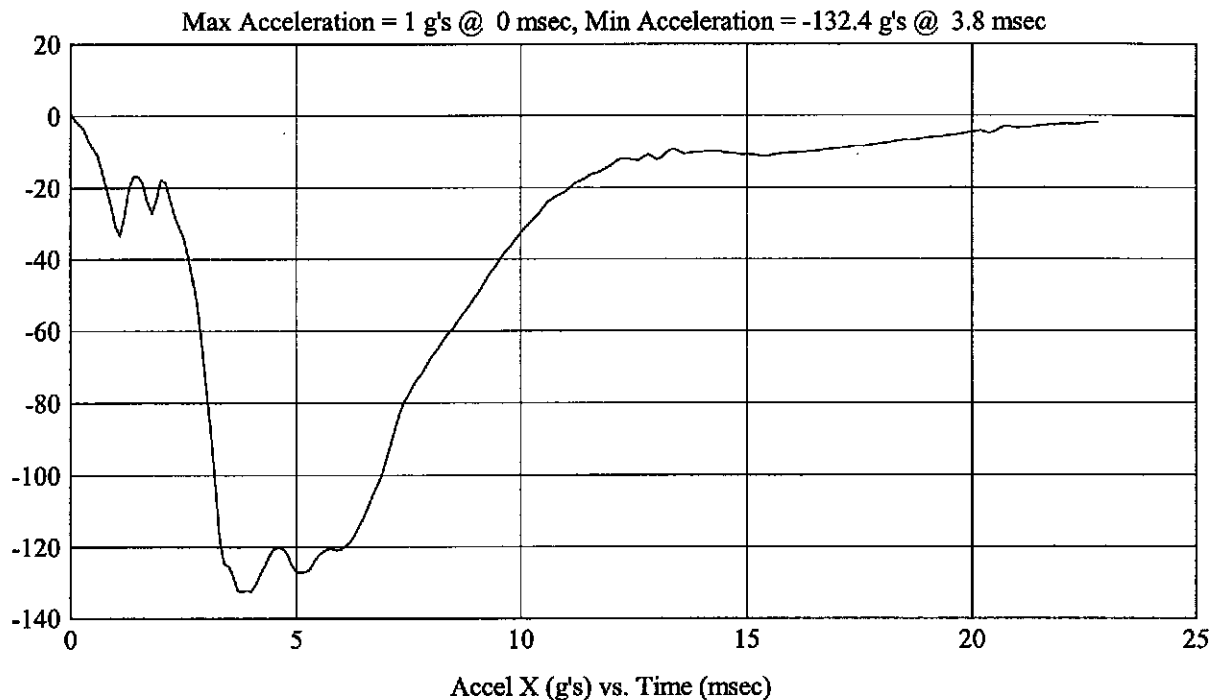
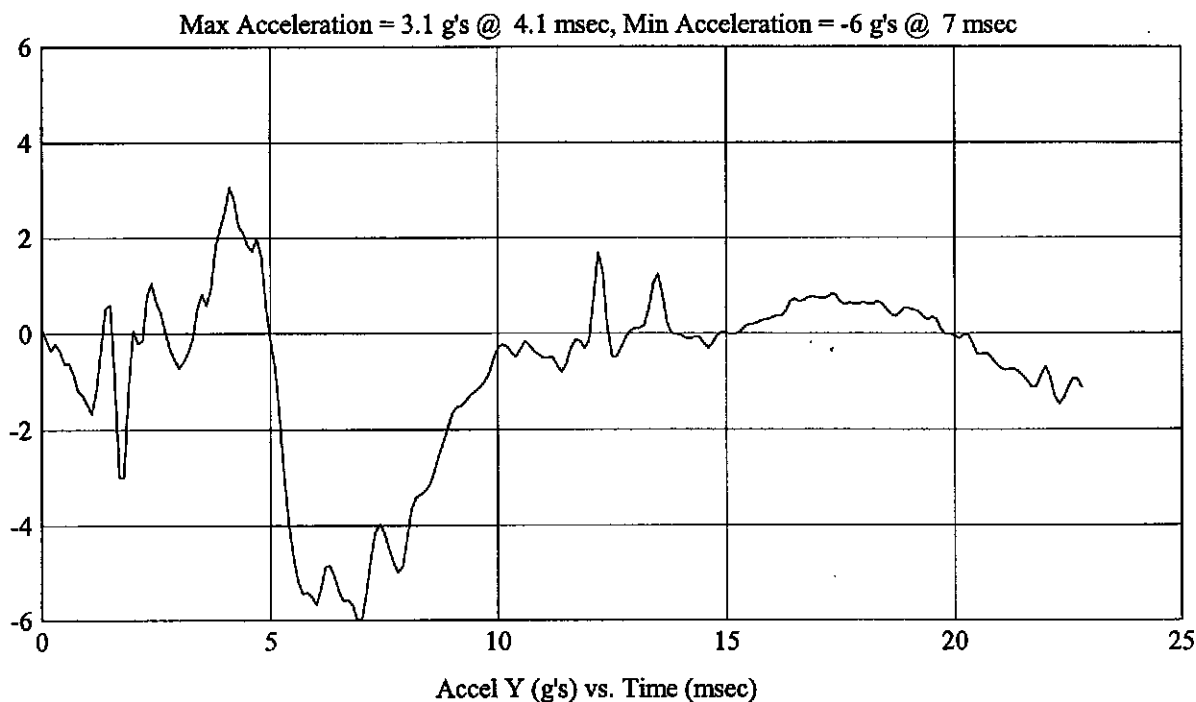
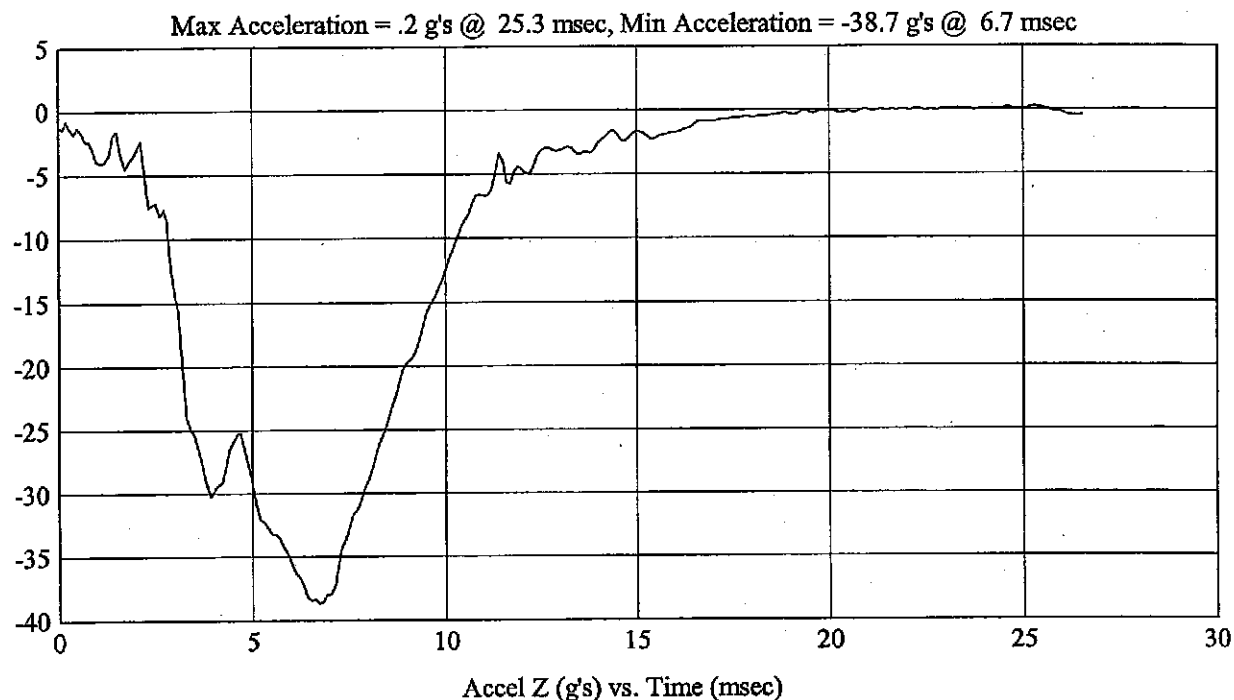
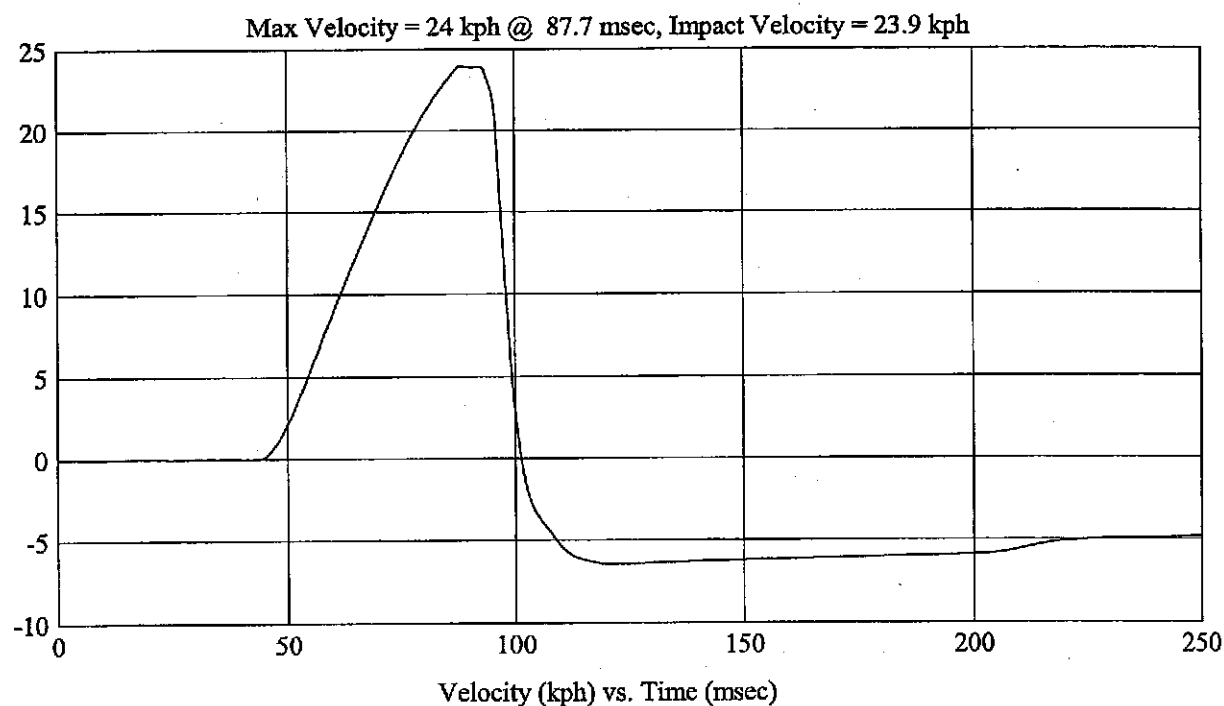
Model Year: 2004
Target: BP2
Vehicle Side: Right
Horz/Vert Angle: 90/3

SEAT BELT ANCHORAGE COVER WAS CRACKED DURING IMPACT

HIC(d) = 714, HIC = 725, Delta T = 5.4 msec

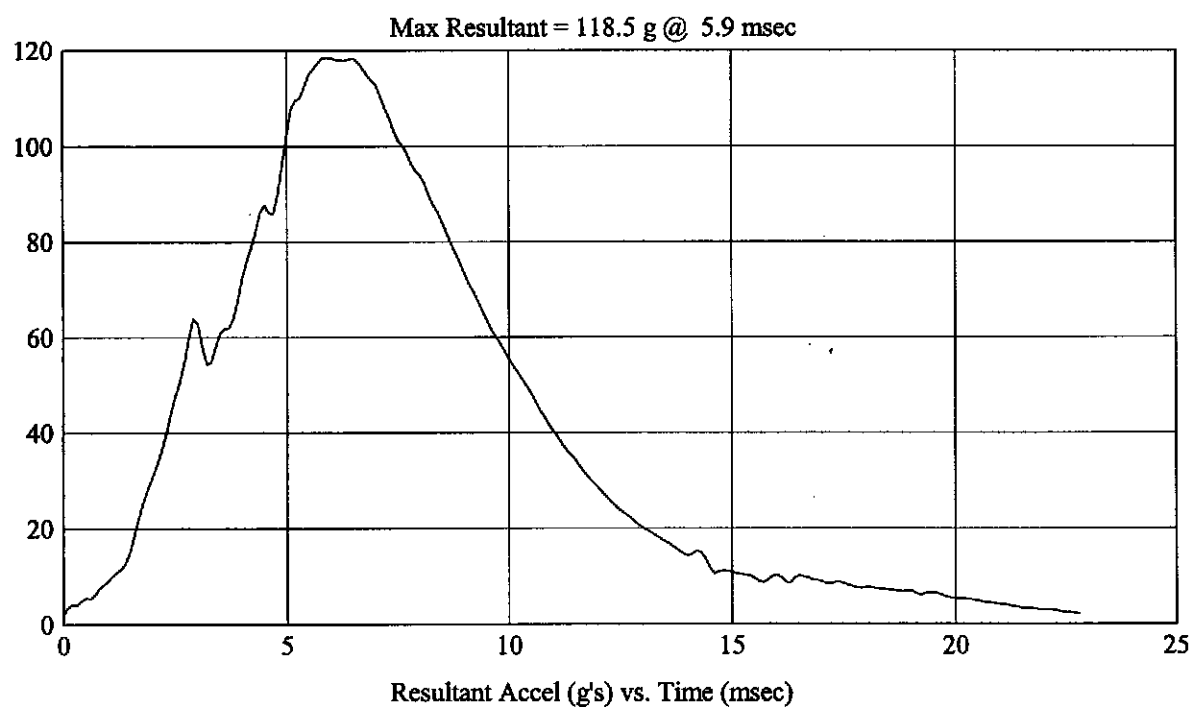
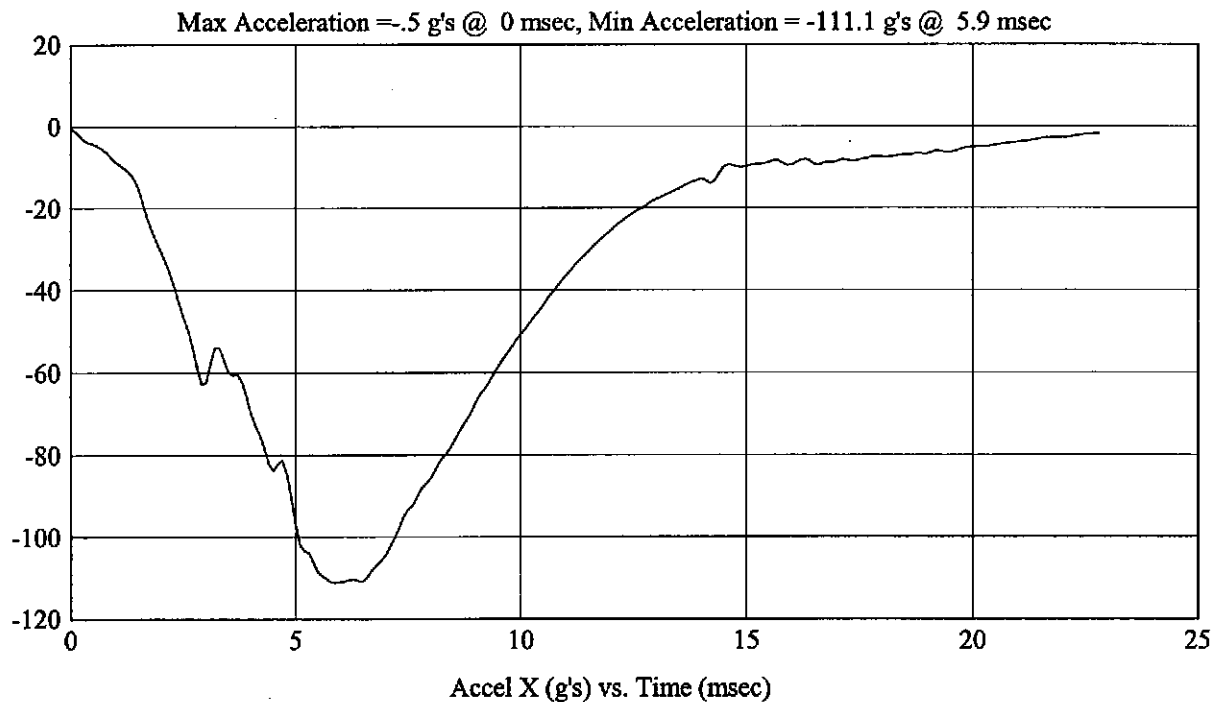
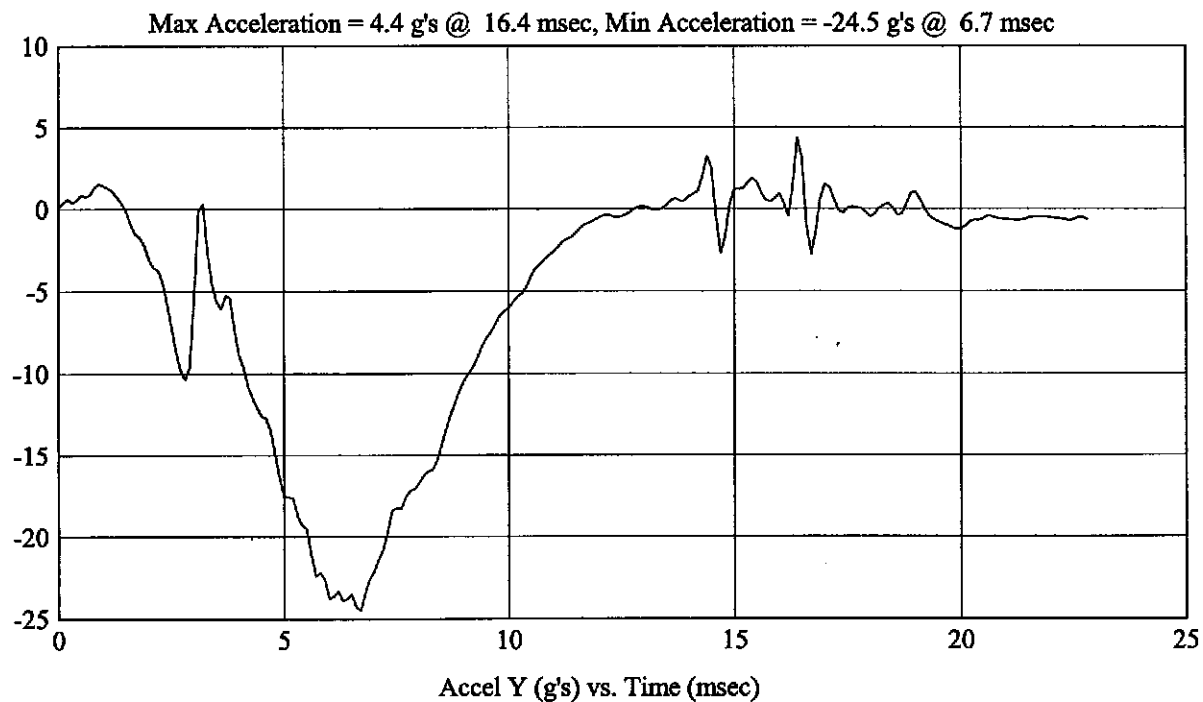
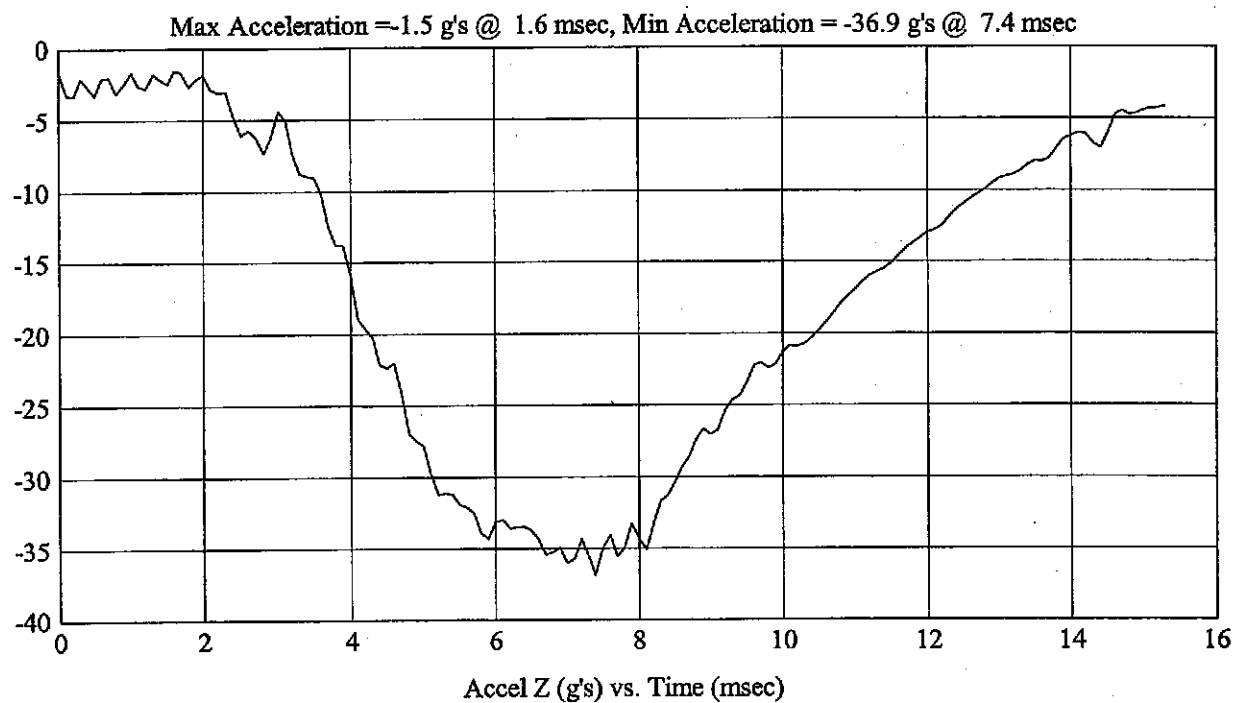
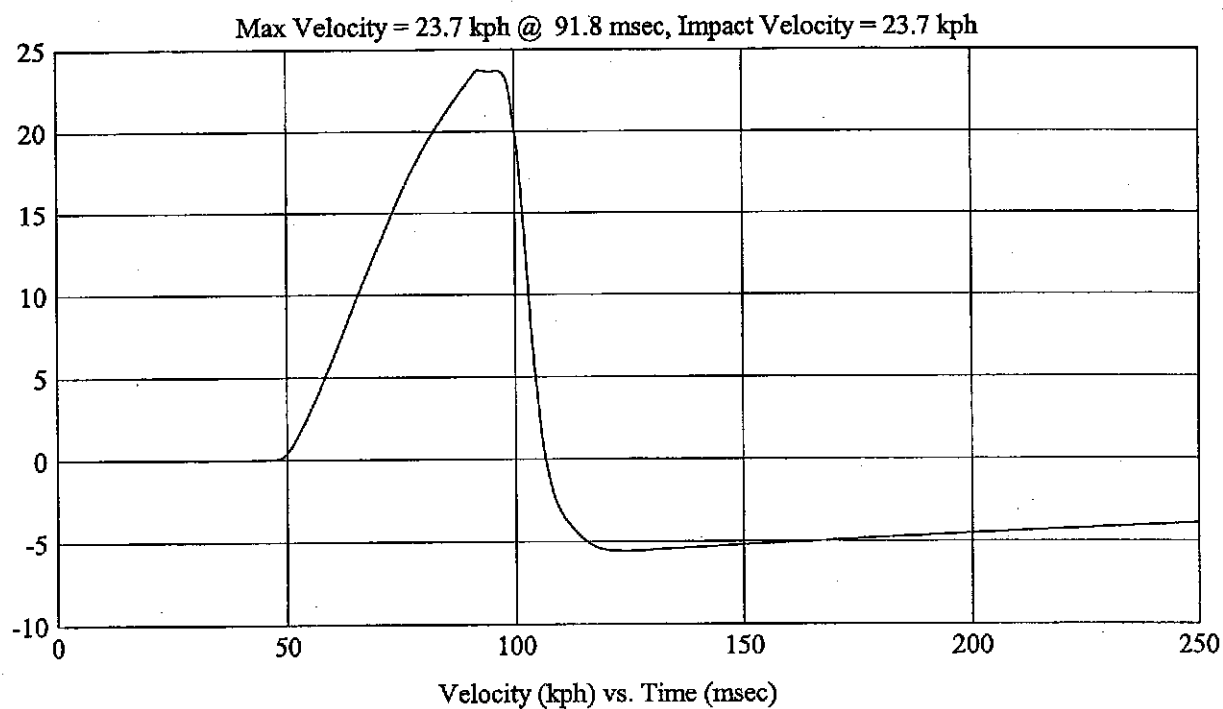
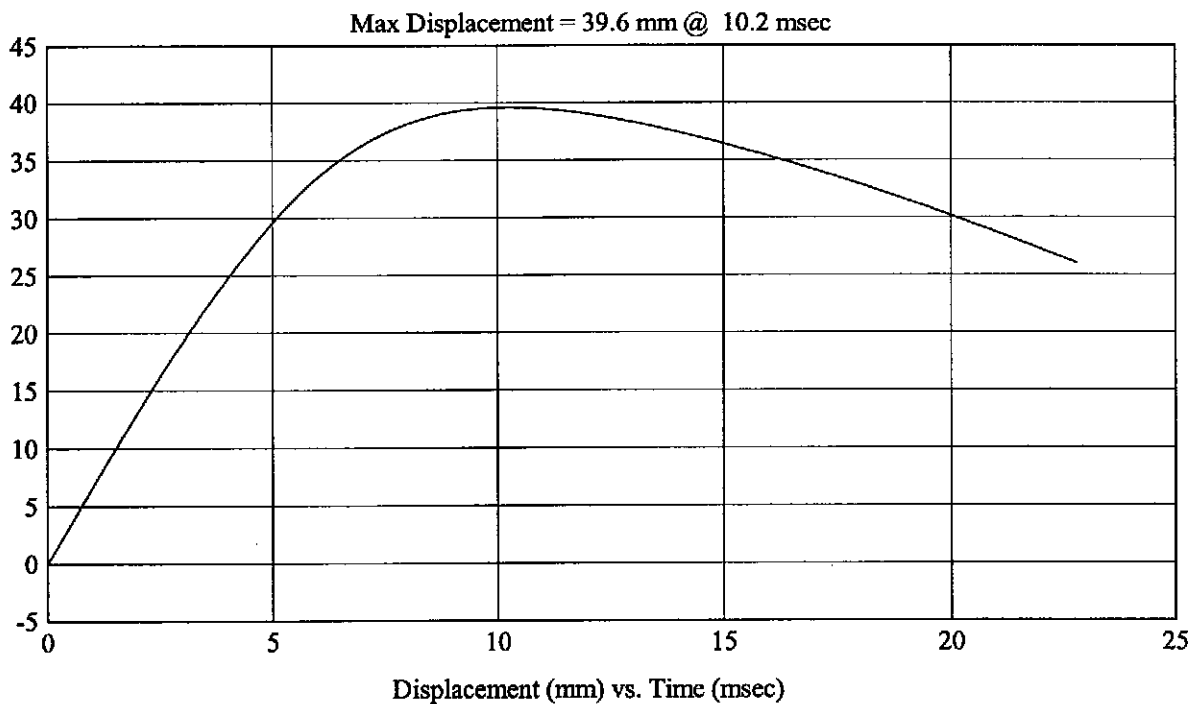
Model Year: 2004
Target: BP3
Vehicle Side: Left
Horz/Vert Angle: 270/1

HIC(d) = 571, HIC = 536, Delta T = 7.6 msec
